MONITORING OF ACOUSTIC EMISSION IN DESTILA MICRO-BREWERY

The acoustic emission (AE) method has been used to monitor fermentation process in Destila micro-brewery. In the pilot phase of the research, 3 piezoelectric sensors have been placed on the outside of the cylindroconical fermentation tank assembly and acoustic signals have been measured continuously for the entire fermentation period. The sensors' purpose was to "hear" carbon dioxide bubbles emerging inside of the fermentation tank and to pass signals to the AE analyzer/laptop PC for further processing. As the fermentation tank is made from Cr/Ni stainless steel, several issues have been registered including sound wave propagation modes within the tank body.

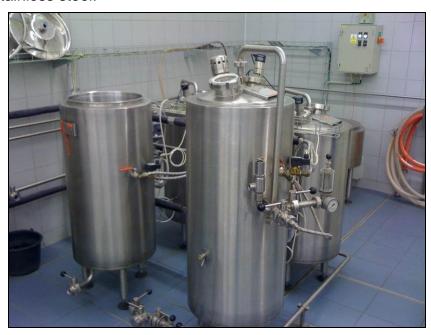
Figure 1: Fermentation part of Destila micro-brewery facility. The cylindroconical fermenter is in the foreground. Photo by D. Varner

In Mendel University, there is a Destila micro-brewery in the food production laboratory of the Department of Agriculture, Food and Environmental Engineering. The Destila system serves for model and/or analysis purposes. It allows for amount modifications of malt, hops, yeasts, and other ingredients. The temperature can be streamlined within the actual brewing process as well. The variable configuration features make the micro-brewery an ideal ground for various research projects. Figure 1 shows the fermentation section of the micro-brewery.

and secondary fermentation in storage tank. The cylindroconical fermenter is made from Cr/Ni stainless steel.

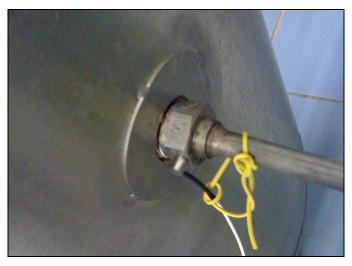
SENSOR1 has been placed on the bolt head of the temperature gauge fixture. This position is on the side of the fermenter. As the bolt head is directly attached to the gauge rod immerged in the tank contents, SENSOR1 was supposed to get closest possible contact with the hopped wort (see Figure 2).

Figure 2: Position of SENSOR1 on the temperature gauge. Photo by D. Varner

SENSOR1 – produced flat RMS curve with very rare AE events (supposedly bursts of the bubbles). No trends have been visible in the graphs.

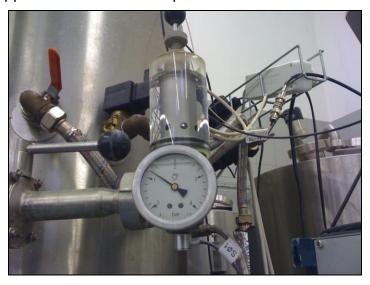
SENSOR2 has been placed on bottom side of the carbon dioxide outlet valve assembly (see Figure 3). This part of the device serves as a secondary source of fermentation intensity level. A gauge shows pressure of carbon dioxide in the tank above the hopped wort level. Obviously, the more bubbles emerge from the piping, the more intensive the internal process is. Placing SENSOR2 in the outlet body of the valve was the only way of visual relationship between signal and actual fermentation intensity. Thus, this sensor was initially meant just for support purpose. The actual AE was probably caused by mechanical motion of internal valve components rather than by actual hopped wort fermentation processes.

Figure 3: Position of SENSOR2 on the bottom of the carbon dioxide outlet valve assembly. Photo by D. Varner

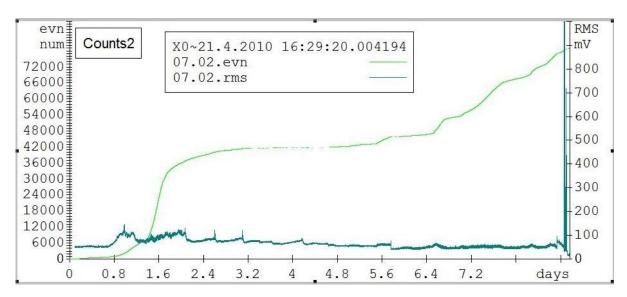
SENSOR2 – produced some usable results featuring steep rise of AE events and correlating RMS. However, while RMS shows descending trend towards the end of experiment, the AE events for some reason keep on higher count level. As SENSOR2 measured secondary activity of valve components, this data DO NOT represent actual fermentation-related carbon dioxide development. On the other hand, the quantity of CO2 bubbles going through the valve might proportionally correspond to the fermentation process intensity. A chart with cumulative AE event count versus RMS trend is shown in Figure 4. The extreme rise of RMS at the very end of experiment timeline has been caused by the brewery personnel. Clearly, they have been touching the tank and performing some rich-sound-emitting activities, such as pumping or rinsing.

Figure 4: Data acquired from of SENSOR2. Note the green curve of cumulative AE event count and blue curve of signal RMS values. Plot generated by the Dakel DaeShow software.

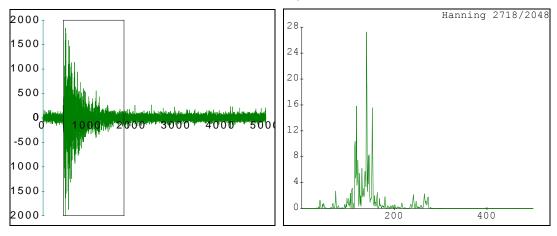
As far as the PSD function of SENSOR2 data is concerned, typical spectral distribution in the signal is shown in Figure 5. However, as stated above, this is not a relevant process-related data plot, but rather a secondary process property (probably a mechanical motion of the valve mechanism).

Figure 5: PSD data acquired from of SENSOR2. Plots generated by the Dakel DaeShow software.
