MONITORING OF ACOUSTIC EMISSION IN DESTILA MICRO-BREWERY

Abstract

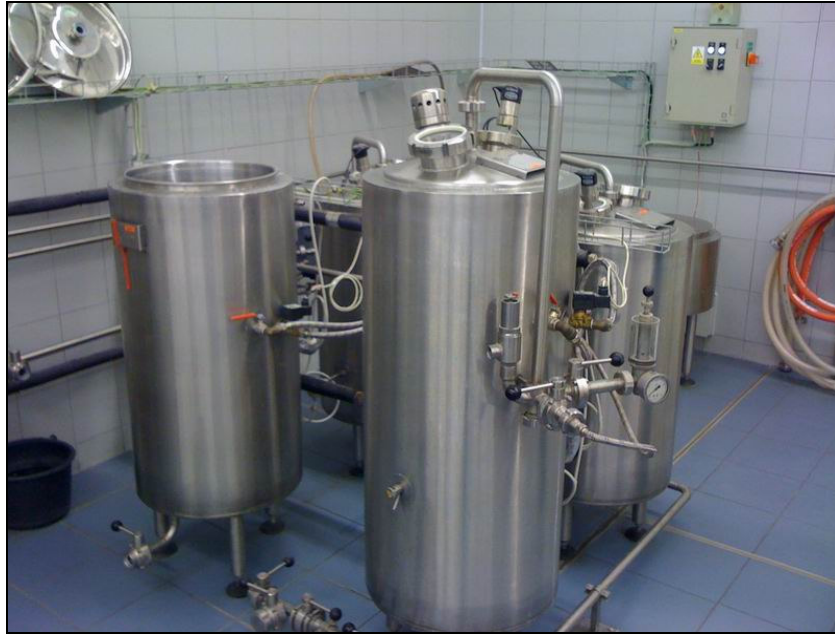
Figure 1: Fermentation part of Destila micro-brewery facility. The cylindroconical fermenter is in the foreground. Photo by D. Varner

In Mendel University, there is a Destila micro-brewery in the food production laboratory of the Department of Agriculture, Food and Environmental Engineering. The Destila system serves for model and/or analysis purposes. It allows for amount modifications of malt, hops, yeasts, and other ingredients. The temperature can be streamlined within the actual brewing process as well. The variable configuration features make the micro-brewery an ideal ground for various research projects. Figure 1 shows the fermentation section of the micro-brewery.

In this experiment, beer fermentation process in cylindroconical fermenter tank has been subject to AE monitoring. This device allows for combined and streamlined fermentation process as opposed to primary fermentation in open fermentation tank

and secondary fermentation in storage tank. The cylindroconical fermenter is made from Cr/Ni stainless steel.

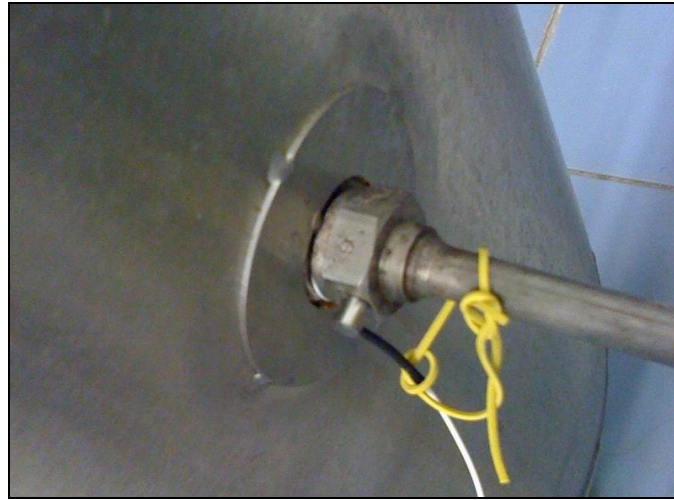
Figure 2: Position of SENSOR1 on the temperature gauge. Photo by D. Varner

SENSOR1 has been placed on the bolt head of the temperature gauge fixture. This position is on the side of the fermenter. As the bolt head is directly attached to the gauge rod immersed in the tank contents, SENSOR1 was supposed to get closest possible contact with the hopped wort (see Figure 2).

SENSOR1 – produced flat RMS curve with very rare AE events (supposedly bursts of the bubbles). No trends have been visible in the graphs.

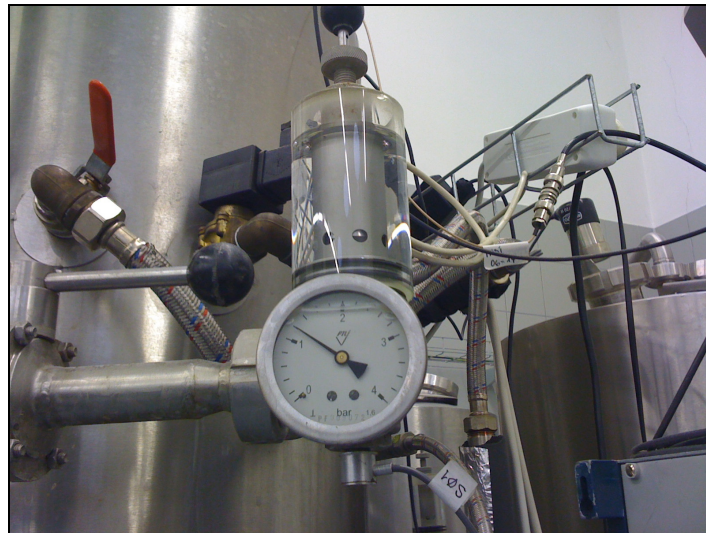
Figure 3: Position of SENSOR2 on the bottom of the carbon dioxide outlet valve assembly. Photo by D. Varner

SENSOR2 has been placed on bottom side of the carbon dioxide outlet valve assembly (see Figure 3). This part of the device serves as a secondary source of fermentation intensity level. A gauge shows pressure of carbon dioxide in the tank above the hopped wort level. Obviously, the more bubbles emerge from the piping, the more intensive the internal process is. Placing SENSOR2 in the outlet body of the valve was the only way of visual relationship between signal and actual fermentation intensity. Thus, this sensor was initially meant just for support purpose. The actual AE was probably caused by mechanical motion of internal valve components rather than by actual hopped wort fermentation processes.

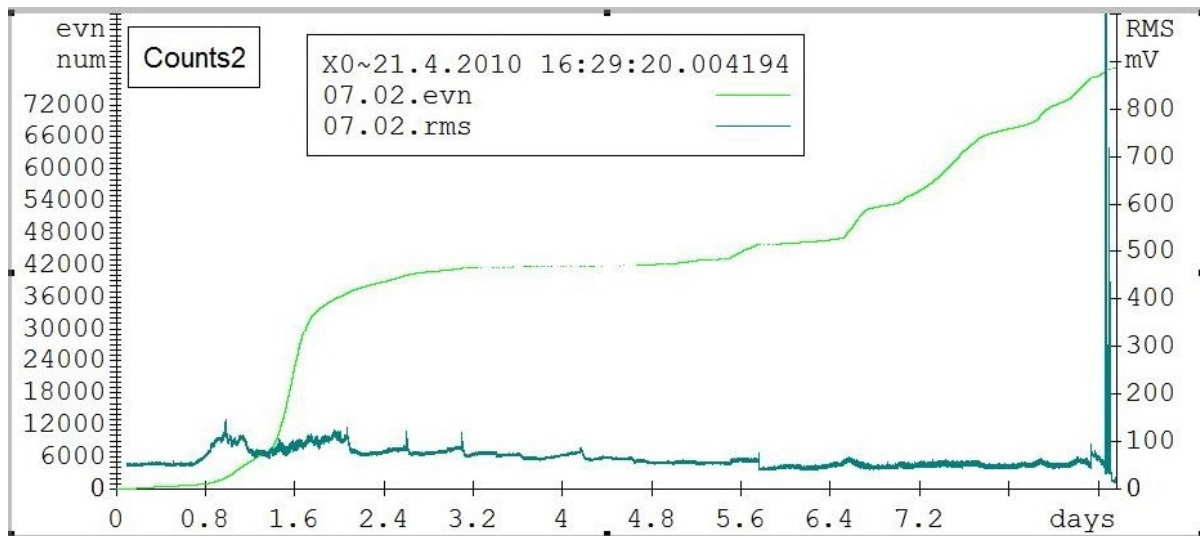
Figure 4: Data acquired from of SENSOR2. Note the green curve of cumulative AE event count and blue curve of signal RMS values. Plot generated by the Dakel DaeShow software.

SENSOR2 – produced some usable results featuring steep rise of AE events and correlating RMS. However, while RMS shows descending trend towards the end of experiment, the AE events for some reason keep on higher count level. As SENSOR2 measured secondary activity of valve components, this data DO NOT represent actual fermentation-related carbon dioxide development. On the other hand, the quantity of CO₂ bubbles going through the valve might proportionally correspond to the fermentation process intensity. A chart with cumulative AE event count versus RMS trend is shown in Figure 4. The extreme rise of RMS at the very end of experiment timeline has been caused by the brewery personnel. Clearly, they have been touching the tank and performing some rich-sound-emitting activities, such as pumping or rinsing.

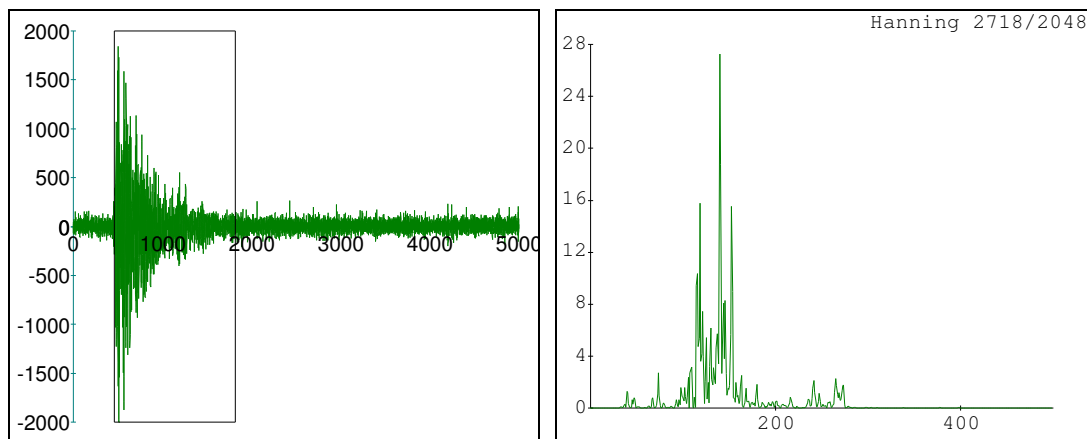
Figure 5: PSD data acquired from of SENSOR2. Plots generated by the Dakel DaeShow software.

As far as the PSD function of SENSOR2 data is concerned, typical spectral distribution in the signal is shown in Figure 5. However, as stated above, this is not a relevant process-related data plot, but rather a secondary process property (probably a mechanical motion of the valve mechanism).
